TRADITIONAL EARTHEN CONSTRUCTION AND REPAIR METHODS IN SARDINIA, ITALY

Enrico Fodde

While vernacular earthen construction has been widely studied, little has been published on traditional repair techniques. By using a combination of technical analysis and interviews with elderly craftsmen, this paper demonstrates that until recently in Sardinia, specific specialised solutions were available in contrast to the situation prevailing elsewhere, notably in Britain.

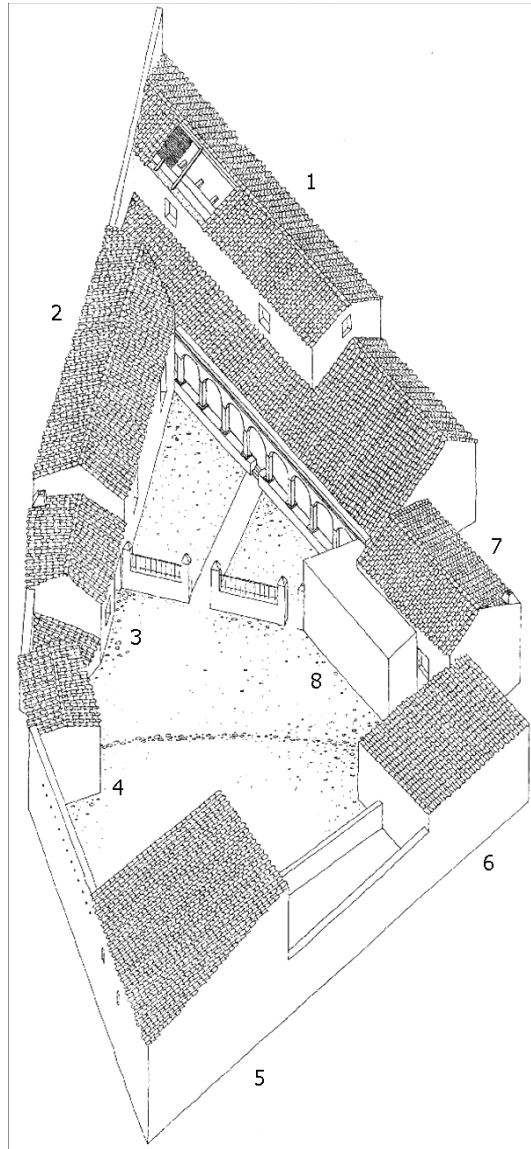
Fig. 1. Courtyard farmhouse, Sinnai. It is a typical introverted space with few or no openings to the outer walls. The illustration shows: residential area with porch (1 and 2), small kitchen with oven for the preparation of bread (3), entrance portal (4), shelter for farm animals (5), storage facilities for wheat (6), and kitchen (7). In many of such buildings one can find 1960's additions made of cementitious blocks (8).

One half of the arable was cultivated and the other left to rest fallow for one year. The land beyond the *viddazzone* was known as *saltus* and was used mainly for grazing. This concentric medieval organization of the area surrounding the villages of Campidano is reflected in the settlement morphology: villages have a circular layout because they are the result of the gradual addition of many courtyard houses over time. Size of farmsteads relates to that of the holding⁴: ‘... courtyard areas are proportional to the surface area of the cultivated land’. Consequently, the grandest vernacular architecture in Campidano relates to the size of the estate, the wealthiest owners being able to afford highly sophisticated houses that incorporated a series of annexes such as the mill, the well, a house for servants, storage rooms, the stable and the barn (Figs.1 and 2).

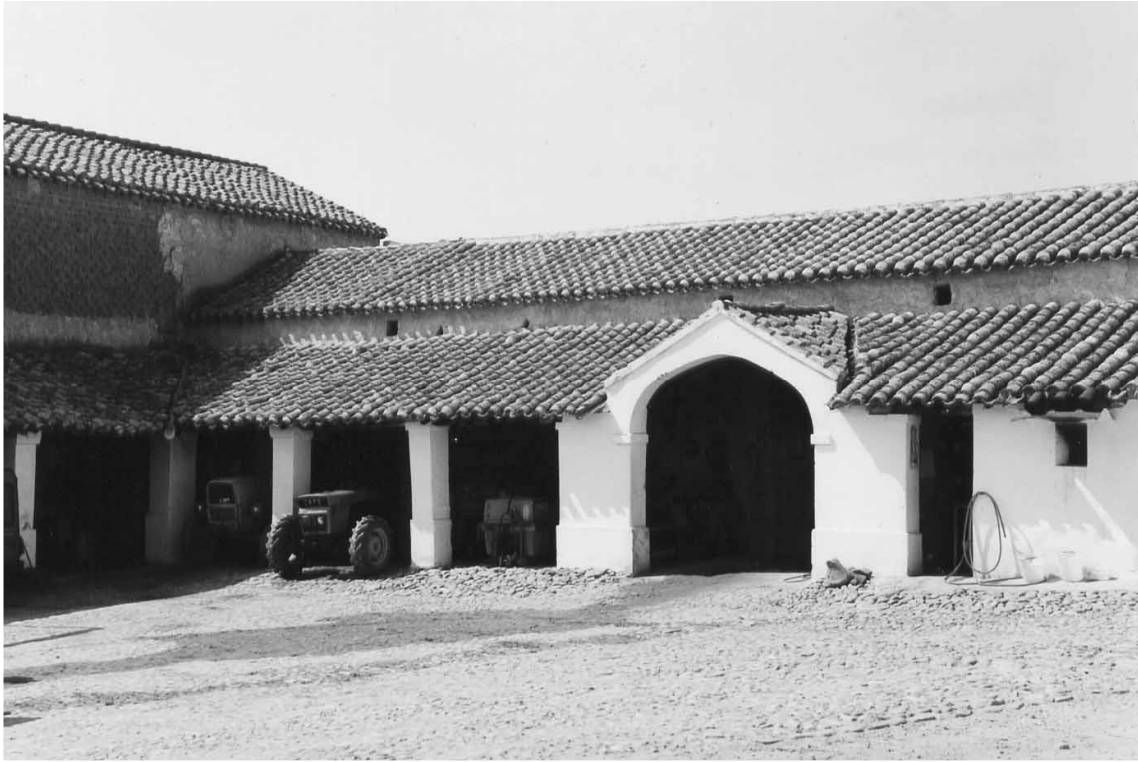
Fig. 2. Nineteenth century courtyard farmhouse showing shaded loggia and cobbled paving (village Ussana)

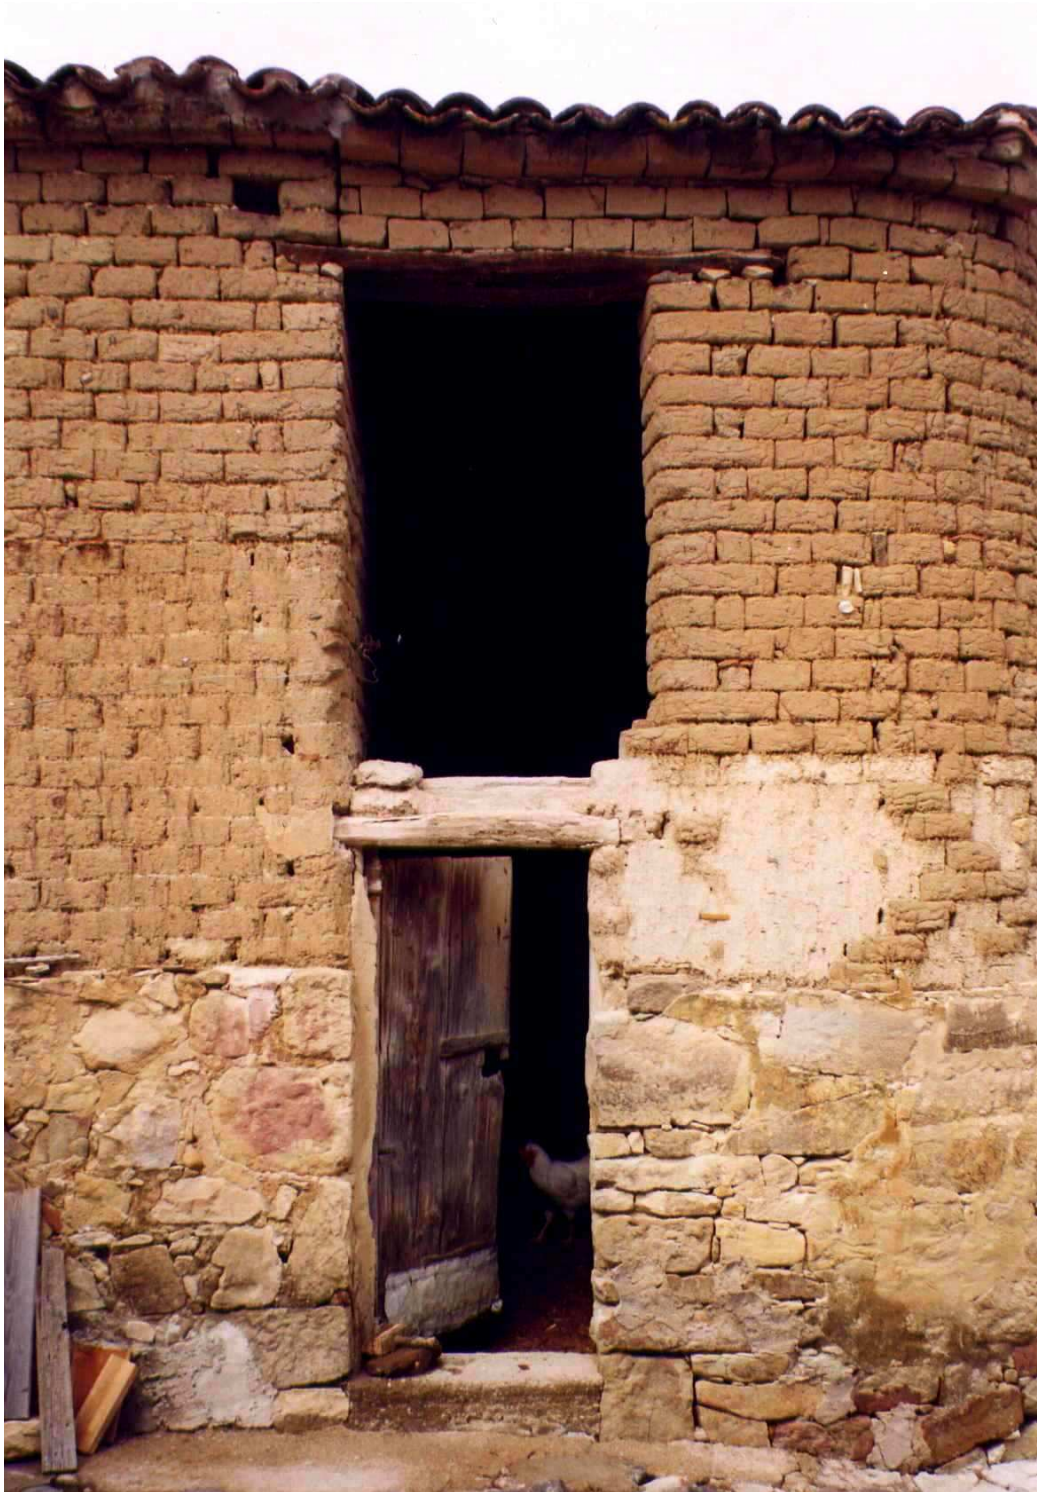
Fig. 3. Granary entrance showing mixed use of stone and mud brick (Villaurbana)

Scaffolding was made of timber boards and posts to form a level platform. In some villages scaffolding was cantilevered by inclining two iron bars (*trampabis*, 30 mm in diameter) in the vertical joints of the mud brick wall (in the *cummussura*) to support the boards. Bricks were often thrown up from the ground to one intermediate level of the scaffolding and then thrown again to another craftsman positioned on the top of the wall. The bricks were stacked on top of the wall and mud mortar raised to the wall head in wooden baskets that formed a platform for the craftsman to stand on during the construction of the next course. Mud brick had to be completely dry because their interface with the fired bricks used for dressing corners (*contonara*) or the arches of portals would be subject to dislocation if substantial shrinkage occurred whilst drying out (Fig. 3).

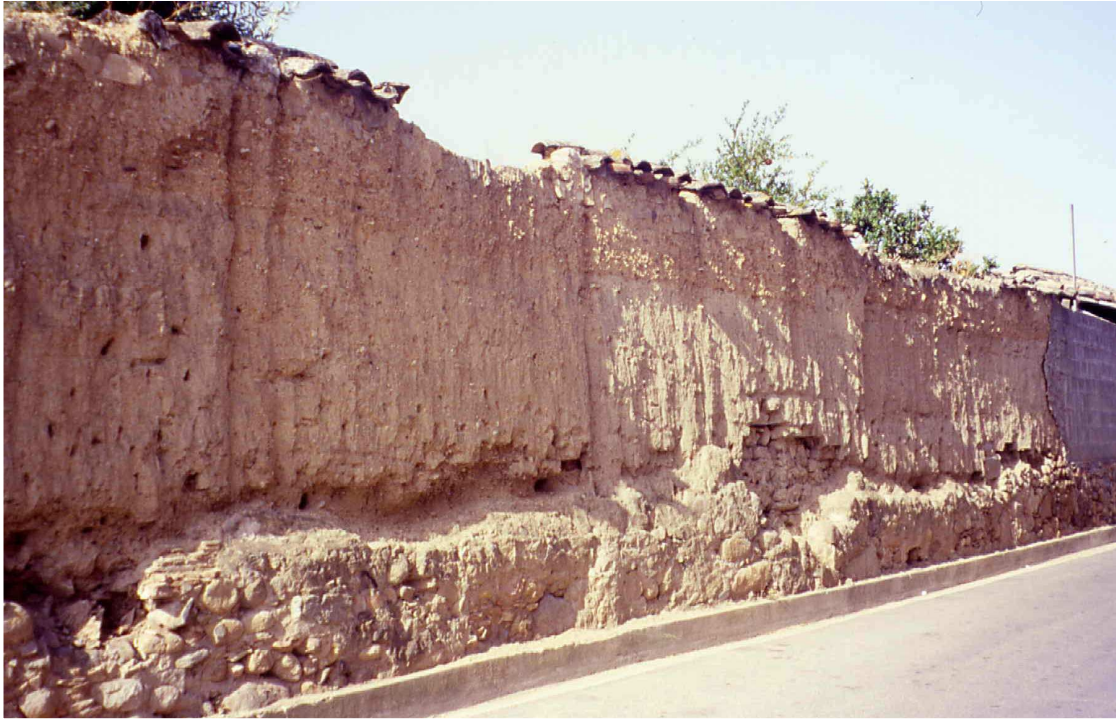
Fig. 4. Typical decay patterns in a boundary wall (Serramanna)

The traditional repair methods illustrated here can seldom be identified on buildings since they are often concealed by render. In some cases master craftsmen were able to show the author the repairs they carried out half a century ago on specific buildings (Fig 4).

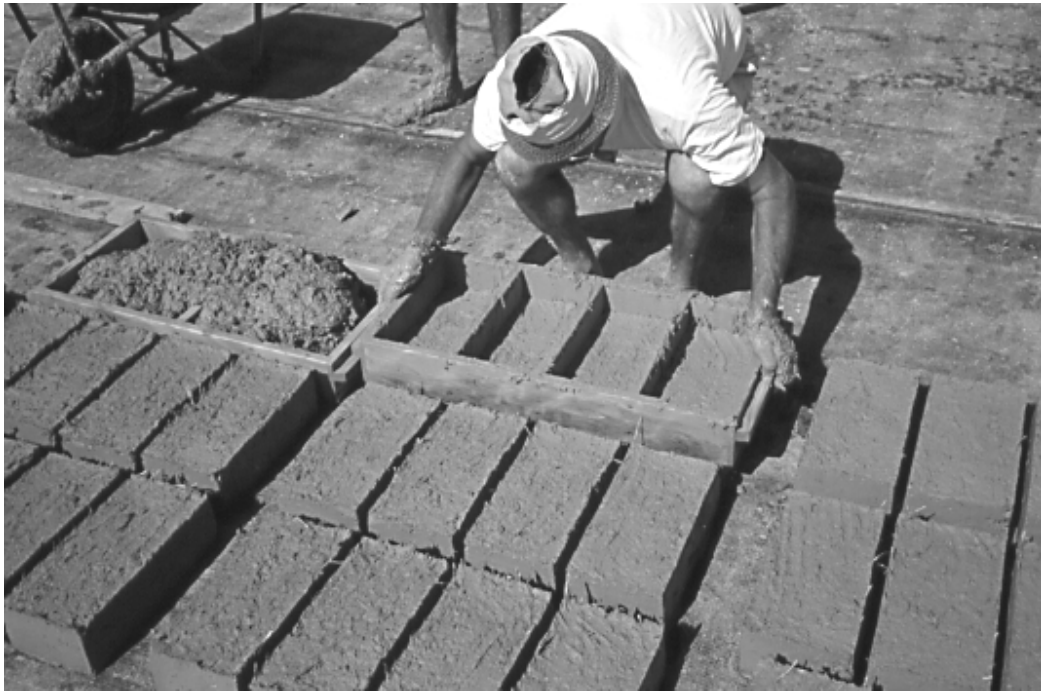
Fig. 5. Mud brick making

When the mix was ready (Fig. 5), bricks were manufactured (*pesai su làdiri*) with a wooden mould (*sestu*) made of four sides, with two handles and without a base. The mould was filled with mud and its four corners compacted (*accraccangiai in is orus*) in order to make crisp bricks that would later form straight walls. The mould was then hand-levelled with the help of some water and emptied to the flat drying ground covered with straw. Bricks were turned and left to dry for a number of days before use, which was commonly five days in summer. When the drying process was over, every brick had to be checked and its corners trimmed and made sharp (*arrasigadura*) with a hooked tool called a *pudazza*. (Fig. 6) Once dried, bricks could either be stored (*abbigadura*) away from rain and damp, or immediately used for building. During storage, a gap of at least three centimetres was left between bricks and this allowed complete drying.

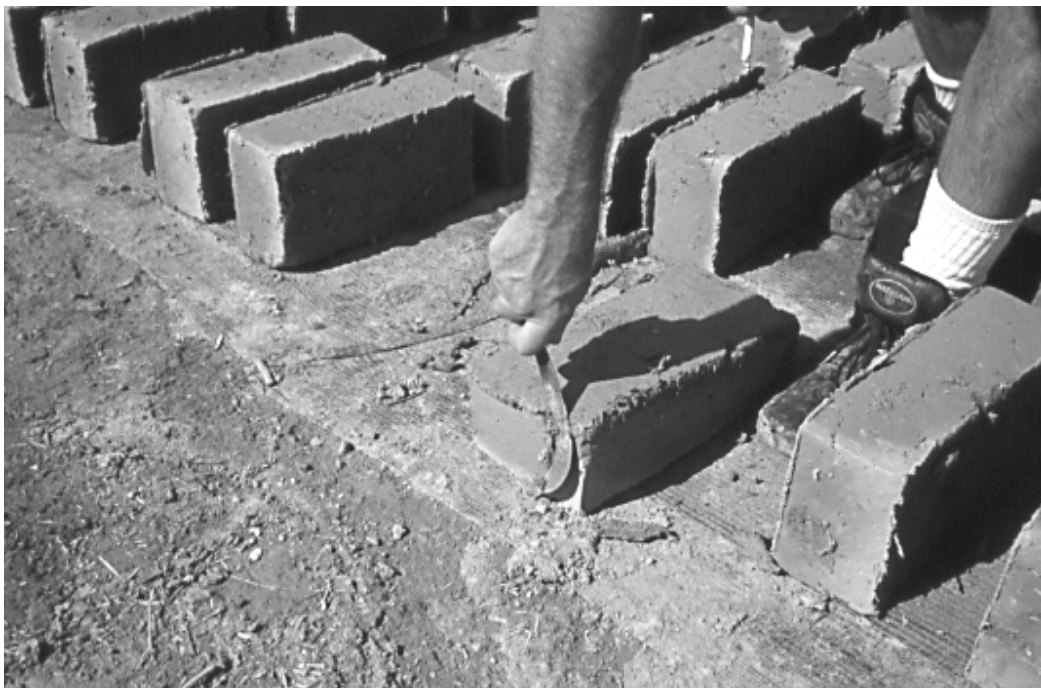
Fig. 6. Cleaning bricks from protrusions

Tools for the making of mud bricks vary little from one part of Campidano to another. The mattock was used for mixing soil with water and straw¹³. The mix of soil and straw was brought to the moulding area in a trapezoidal wooden container –filled by shovel- which could hold exactly the right amount of mix for two mud bricks. The moulds (Fig. 5) were made with boards of 2.5cm thickness, with two handles. The dimensions of dry bricks were 10x20x40cm and other dimensions maintained the proportion 1x2x4. Bricks for use in the construction of hemispherical ovens were called *ladireddu* (small *làdiri*) and were made with a truncated pyramid mould (*sestu pitticcu*) with two handles. These smaller bricks were 18x10.5cm wide on the principal face and 12x8.5cm on the minor side and 20cm high¹⁴. Their shape facilitated the construction of the dome of the oven without the need for centering. The tool called *pudazza* was made of a timber handle 10cm long and a hooked steel knife 15cm long. Its main use was in the pruning of vines, but it also was used for the cleaning of corners of the bricks after drying occurred¹⁵ (Fig. 6). Bricks had a slight concave shape due to their own weight when drying and laid with concave side down. In so doing bricks could set firmly in the mud mortar and water could be forced to move downward to the outside of the surface where evaporation could occur¹⁶. After a course was laid on the mud mortar, bricks were gently beaten with the top of a pickaxe (*piccu*) in order to improve bonding¹⁷. Mud mortar for the laying of bricks was transported with buckets passed from hand to hand along a human chain. When bricks had to be cut, especially for conservation purposes, a special tool called *marteddu a tallanti* was used. It was basically a hammer with one sharp side similar to an axe. After four grooves were impressed in the four sides of the brick to cut, the hammer was used to cut the brick and to remove lumps.

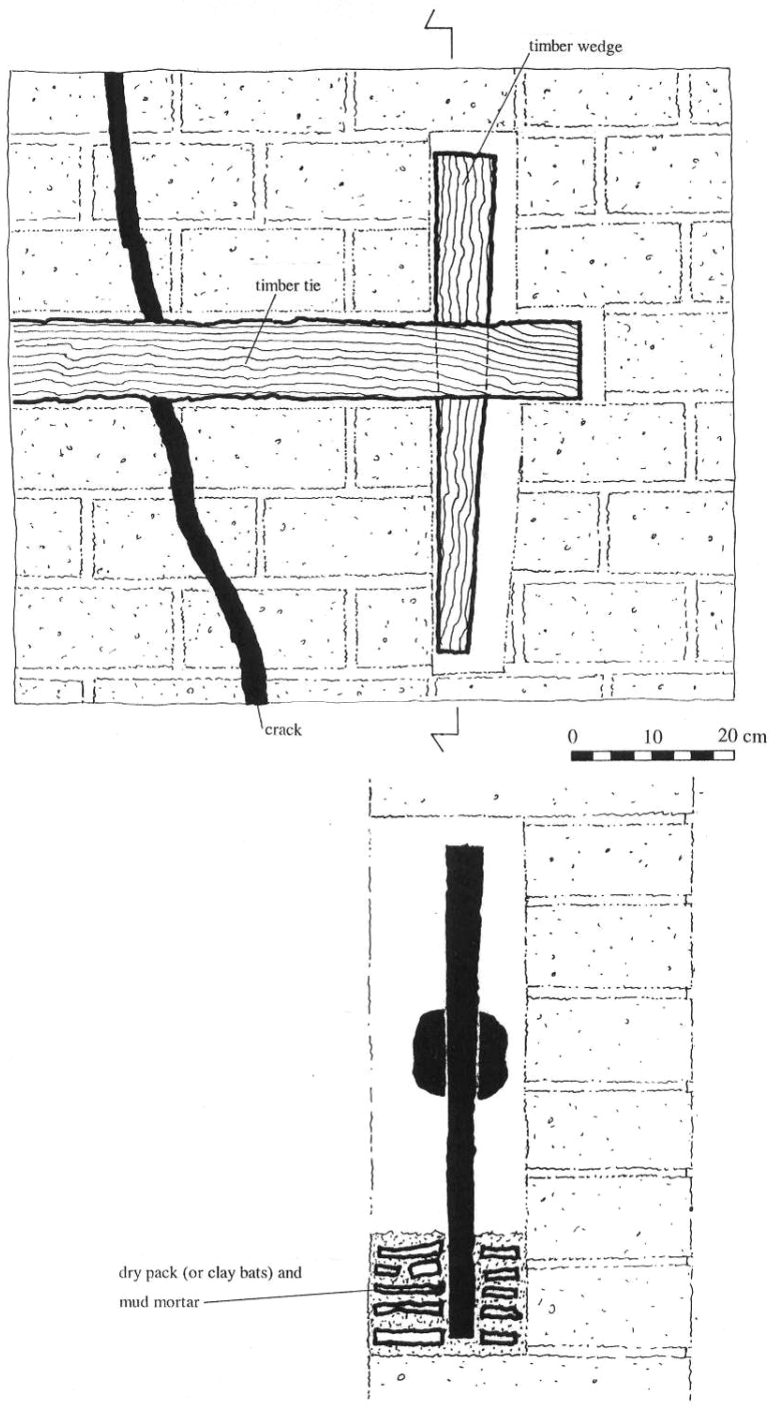
Fig. 7. Traditional stitching method for wall cracks. The timber tie ends on the right hand side with another wedge similar to the one on the left. The idea behind this method is to connect the two parts of wall that are separated by the crack.

In some cases structural cracks were cleaned of all loose material and plants, wetted and filled in with tiles or flat stones, mud mortar, and dry packed. Skilled craftsmen explained that structural cracks were stitched by inserting juniper or chestnut ties (or hooks) in order to establish a solid connection of the two parts of the wall (Fig. 7). The reason for using timber is related to its compatibility with earthen buildings, being flexible and vapour-permeable. The stitching method restricted further movement, but did not eliminate of the underlying cause. If, for example, a crack measuring two metres in length was to be stopped from expanding, two ties were inserted at 50cm from both extremities of the fracture. In order to do so, a chase 20cm deep - exactly half the thickness of the wall - was cut in order to accommodate the timber tie which was then fixed at both ends with two timber wedges. One end was fixed first and then the other extremity was fixed and tightened with a cross-tie end-securing method. Ties measured 10cm in diameter and one metre in length and were characterised by two dovetail holes at both ends, and by two end-securing methods (*crai*, key, or *cravatta*) with a vertical and a diagonal side. Ties were fixed on the wall and keys were hammered in the holes and kept tight by simple friction (*attesai*), without any nails (*obbibisi*) or wedges (*taccius*). Some master craftsmen agreed that the longer the keys, the greater the benefit against cracks. Then the timber tie was bedded in and packed with mud mortar and tile wedges in order to complete the stitch. A certain amount of original fabric was lost when cutting the chase on the wall and the method presents philosophical conservation issues as a model for repair techniques. However, the alternative technique of grouting liquid clay into the crack was not traditionally contemplated by craftsmen as in their experience, clay could shrink after drying.

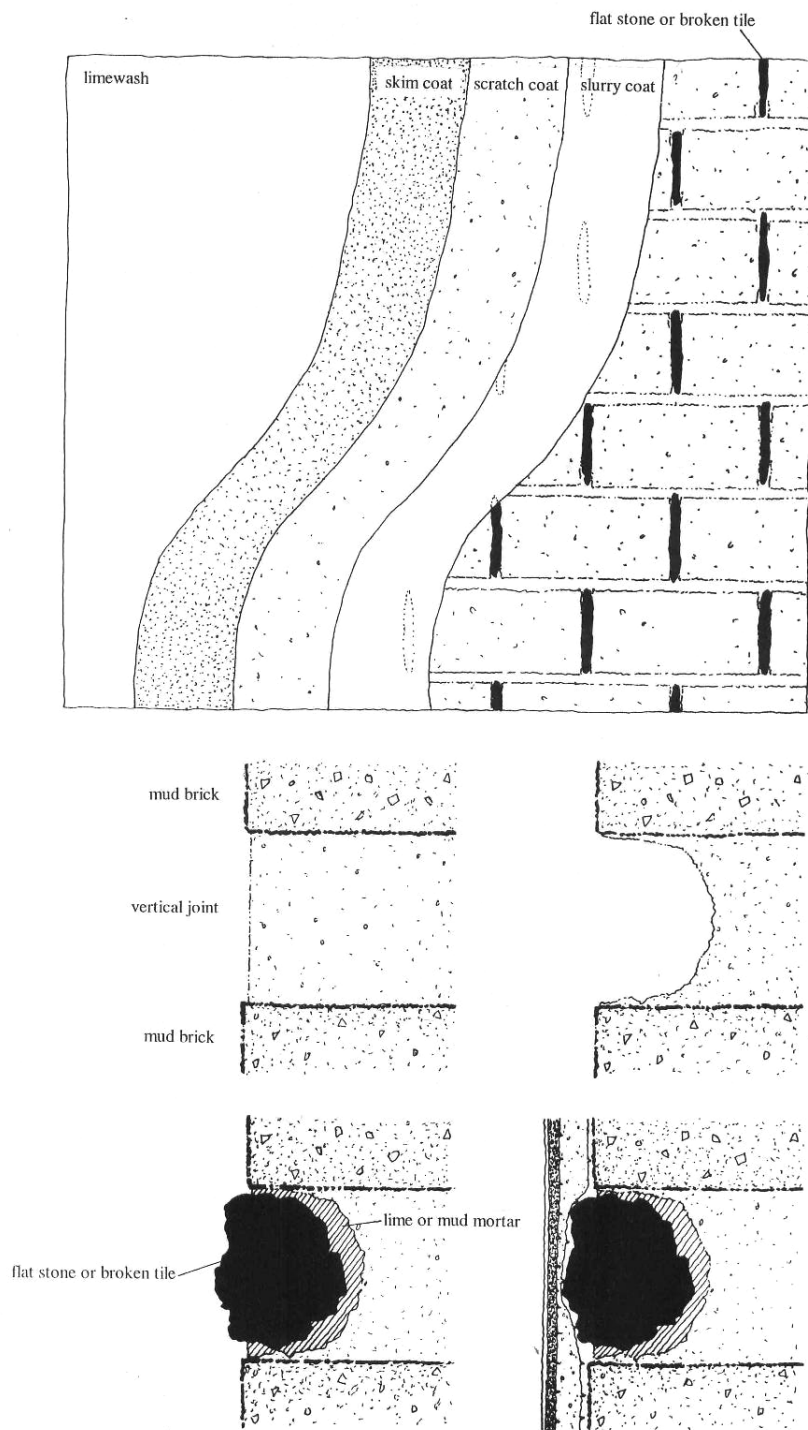
Fig. 8. Traditional repair method for shallow erosion

Shallow erosion was often accepted in Campidano as being a characteristic of the fabric of the earthen wall face which did not require any repair beyond good-quality plaster. The traditional solution for shallow erosion (<10cm) was the preparation of the wall by the insertion of broken tiles or flat stones in the vertical joints (*cummussura*) of the mud brick in order to form a keying system (Fig. 8). Before insertion, joints had to be dug in order to be able to accept the broken tiles and the lime mortar. After the system of tiles and stones was firm, a lime slurry was applied to the eroded area over which, after drying was completed, a coat of lime mortar of thickness 5-10 mm was plastered. A combination of coats was preferred to a single thick coat in order to avoid drastic detachment. Generally speaking, the thickness of every coat was proportional to the depth of the erosion.

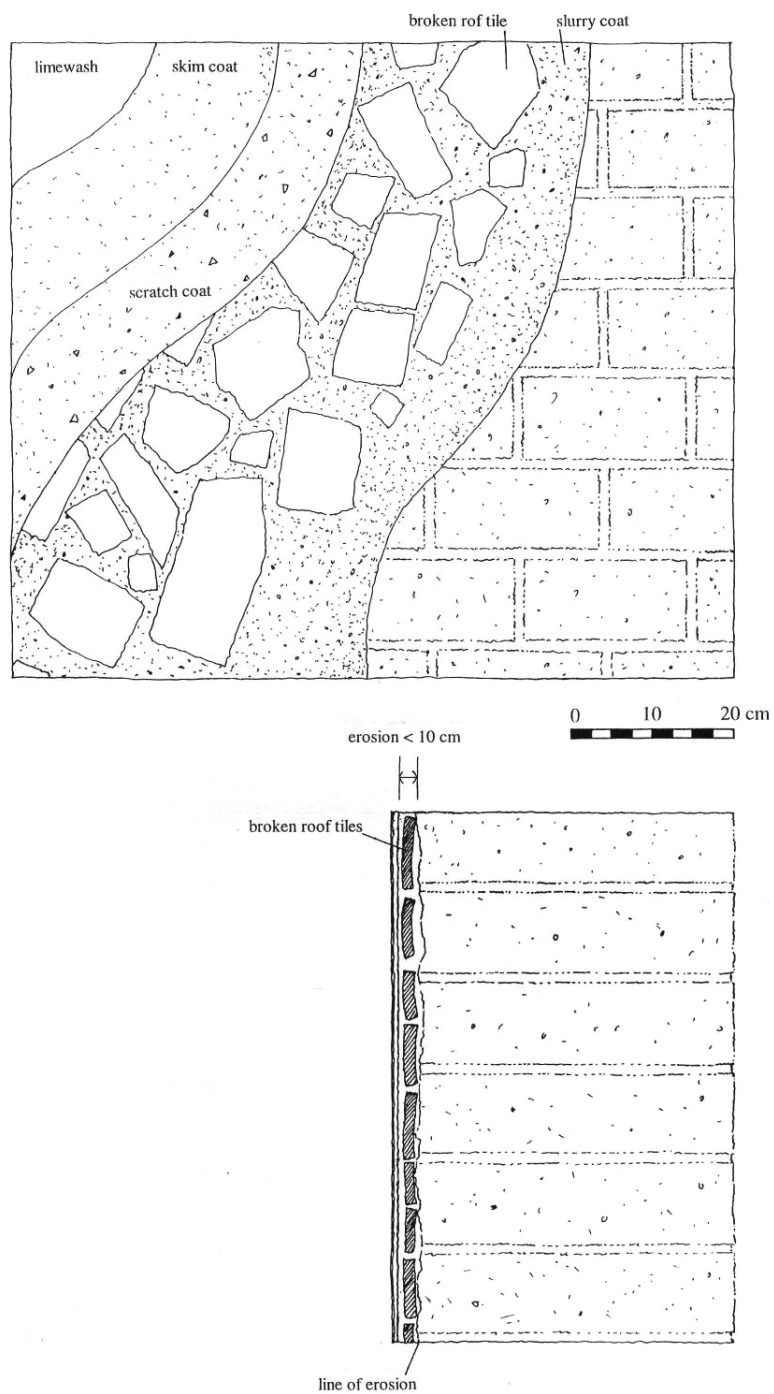
Fig. 9. Traditional repair method for shallow erosion (< 10 cm)

Another traditional method for the repair of superficial erosion entailed the use of broken roof tiles (*teullacciu*) and of flat stones applied parallel to the eroded area (Fig. 9). This created a continuous layer on which the lime render could grip and form a flush surface with the wall line. Patches of loose soil were traditionally consolidated by spraying a lime slurry in order to take the wall back to its original state. It was important to soak the broken roof tiles and the stones in water before use, and to moisten the wall before accepting them. This technique has an ancient origin, as demonstrated by discoveries in the House of Phaunus in Pompei¹⁹ and in Sardinia in the Roman site of Nora. Here earth and stone walls were repaired with a coat of roof tiles bedded in lime mortar, showing that this technique was most probably transmitted during the centuries of Roman control in Sardinia.

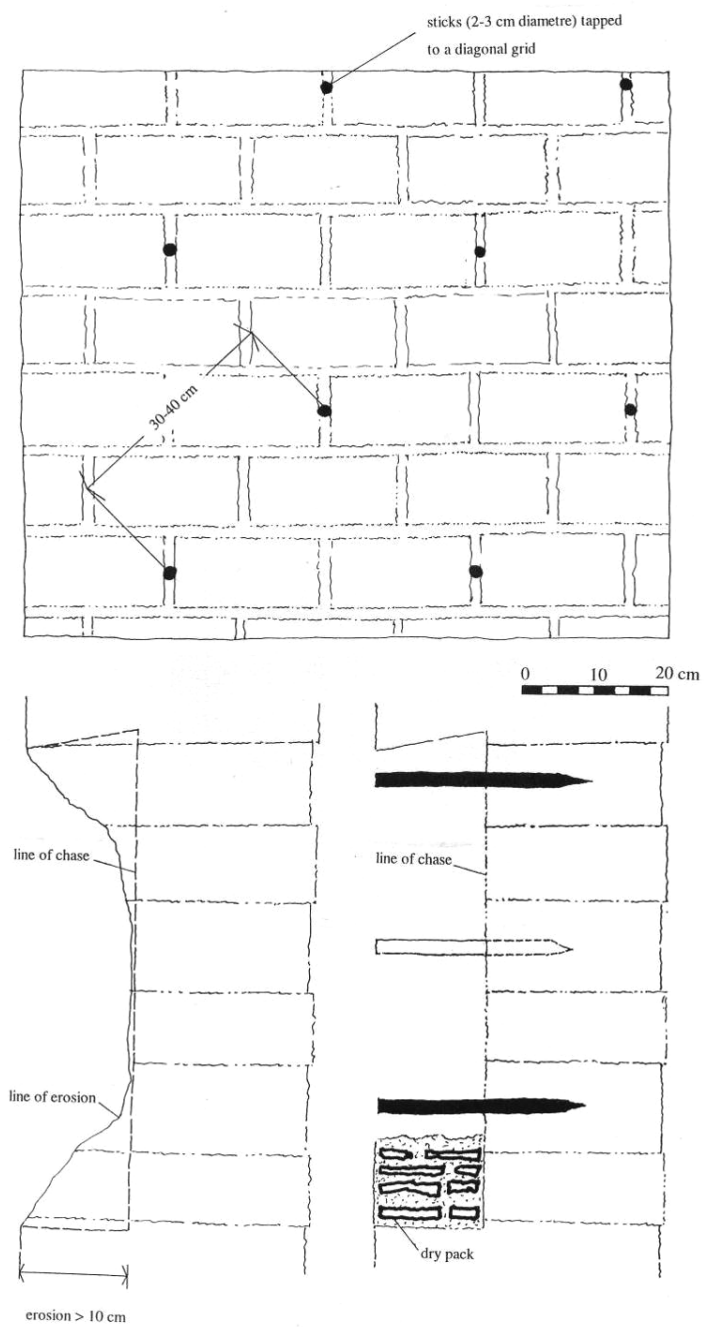
Fig. 10. Traditional repair method for deep erosion (> 10 cm)

In villages such as Sinnai and Villamassargia deep erosion was especially frequent at the base of the mud wall (coving), and was repaired by using the traditional method known as *rincasciu* (Fig. 10). This procedure involved a preliminary brushing-off of all loose earth of the wall surface. If necessary, patches of loose soil were consolidated by spraying a lime slurry on the affected area. Then a rectangular chase with a sloping soffit was hacked into the extremities of the eroded area to form a dovetail section in order to receive a series of pointed wooden sticks (*ancrava*) tapped into the vertical joints of the mud bricks. It should be mentioned here that this is a similar procedure to that adopted by Pearson for cob buildings in the UK²⁰. Sticks were made of juniper or oleaster and measured 2-3cm in diameter and were necessary when erosion was deeper than 10cm. Hammering was carried out until the extremities of the sticks were flush with the original wall line. In order to avoid cracks caused by hammering sticks on a square grid basis, a diagonal grid (*pei tremini*) with sticks 30-40cm apart was preferred. This was necessary to create a tight and solid structure that could form the basis onto which the subsequent step of the intervention could be keyed in. After a flush line was fixed, the chase was wetted and filled in with courses of broken roof tiles, fired bricks, flat stones (*mazz'e cani*), and mud or lime mortar. Sticks therefore had the function of tying these courses to the wall. The use of chicken mesh and nails, typical of modern cementitious repairs, was traditionally avoided because of the certainty of rusting when associated with lime. In some cases pre-shrunk earth bricks were employed instead of fired tiles. Clay bricks were made of the same loam as the historic wall. When fired clay tiles were used instead, traditional craftsmen suggested that this had the disadvantage of sacrificing the surrounding mud bricks to the fired tiles because moisture could be drawn to where the material is softer.
